Manhole Inspection Summary

Manhole # S15U__006MH

Location Address: **1120 WHISTLER AV** Cross Street: **WILMARCO AV**

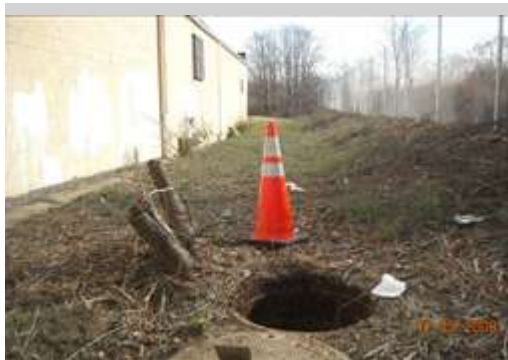
Location View

Comments **LOCATED MANHOLE UNDER CLEARED BRUSH WITH PARTIALLY STUCK COVER FROM CORROSION/DEBRIS @ FRAME/COVER JOINT; STEAM IN THE LINE**
